NASA CR-1915

## THE ROLE OF HYDROGEN IN HOT-SALT STRESS CORROSION CRACKING OF TITANIUM-ALUMINUM ALLOYS

E. I. DU PONT DE NEMOURS & COMPANY

NATIONAL AERONAUTICS AND SPACE ADMINISTRATION • WASHINGTON, D. C. • NOVEMBER 1971

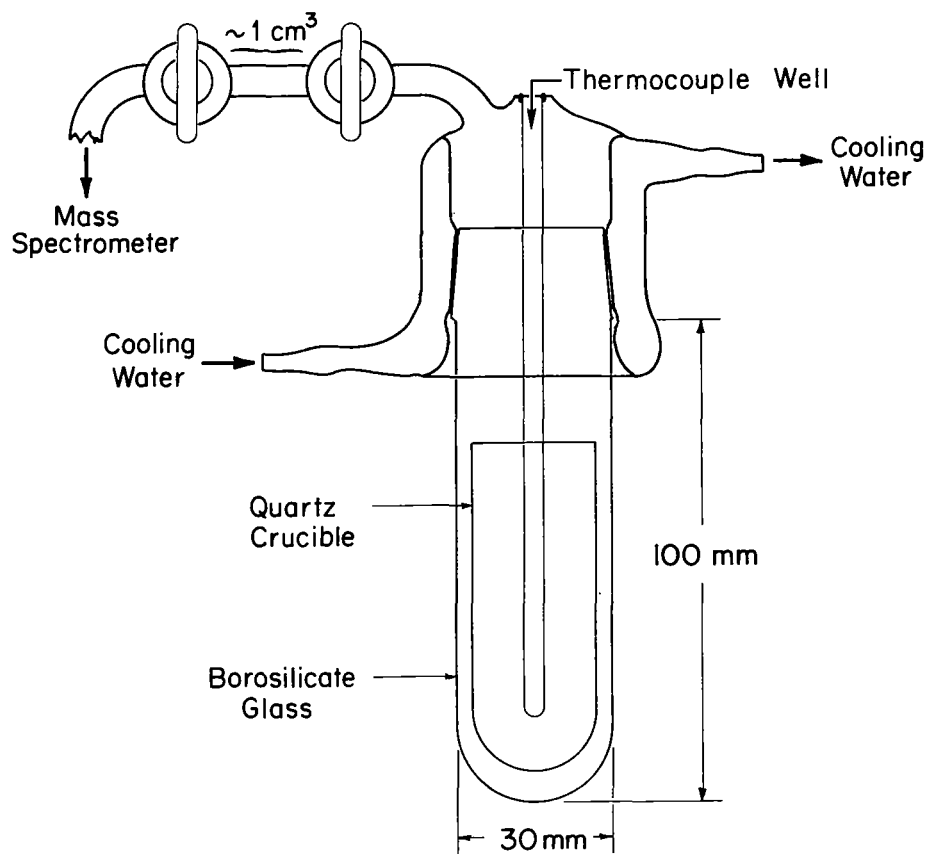
FIG. 1 HOT-SALT/TITANIUM-ALLOY REACTOR VESSEL

Volatile corrosion products evolved from chips of titanium-aluminum alloys coated with halide salt at 260 and 400°C were analyzed with a mass spectrometer.\* The samples were analyzed as follows. Salt solutions were evaporated to dryness on the chips of both Ti-8Al-1Mo-1V and Ti-5Al-2.5Sn at room temperature; some of the salt-coated chips were then heated to 350°C for one-half hour to remove moisture from the salt. These chips were placed in a reaction vessel (Figure 1), and predetermined amounts of water were pipetted onto the predried salted chips (no water was added to the unheated chips). The vessel was partially evacuated so that at test temperature, without a reaction, the pressure would be approximately one atmosphere. After the reaction vessel was attached to the mass spectrometer, the vessel was heated in a tube furnace to the test temperature, and the gaseous reaction products were sampled periodically. About 2% of the gas in the reaction vessel was removed each time a sample was taken.

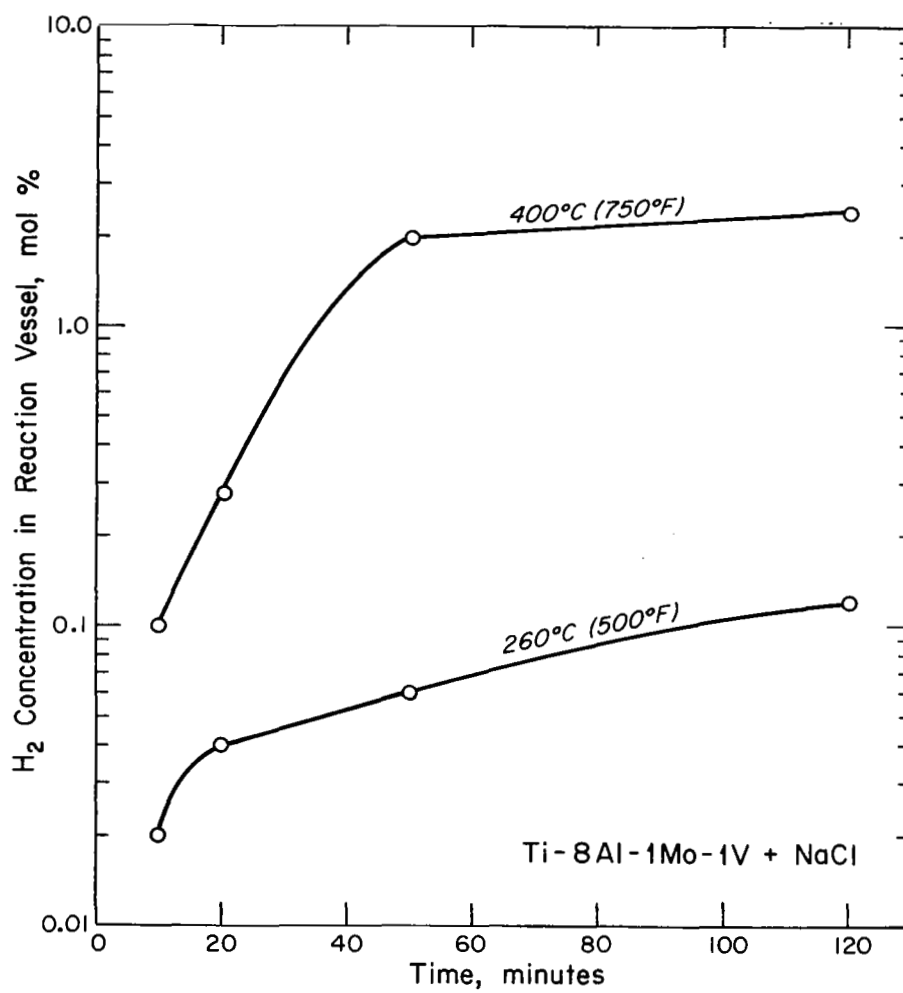
FIG. 2 EVOLUTION OF HYDROGEN IN HOT-SALT CORROSION

The amount of hydrogen evolved on heating the coated chips of Ti-8Al-1Mo-1V that were previously dried at room temperature only is shown in Figure 2 (little difference was observed in the amount of hydrogen evolved from the two titanium alloys). The gas was produced by chemical reactions with the metal. Hydrogen initially present in the metal (equivalent to about 0.1 mol % of the hydrogen evolved) would not be released under these conditions. The higher temperature probably drove more water from the salt crystals<sup>4</sup> which produced more HCl and therefore more hydrogen.

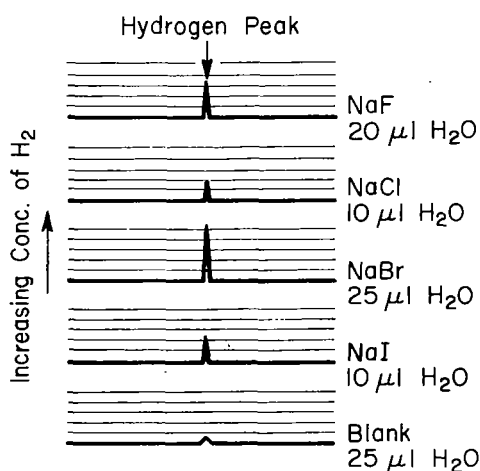
FIG. 3 HYDROGEN PRODUCTION AT 350°C

Evolution of hydrogen from the salt-covered chips that had been previously dried at 350°C was controlled by the amount of water added. The hydrogen evolved was measured after heating for 1.5 hours (sufficient to reach equilibrium), and the relative concentration is shown in Figure 3 for each of the four sodium halide salts and for a mixture of chips and water alone. These results show that the amount of hydrogen produced was proportional to the amount of water added and was insensitive to the particular halide salt. The amount of hydrogen halide that could be produced by pyrohydrolysis and react with the metal to release hydrogen was limited by the amount of water present. The reaction was not a metal-water reaction, as shown by the blank. Other products observed in the reaction were hydrogen halides.

Small amounts of hydrogen produced in this manner can be absorbed by the metal and thereby embrittle the surface,<sup>5,6</sup> NaF does not cause cracking because of the volatility of  $\text{TiF}_4$ , the major product of the reaction between HF and titanium, as previously reported.<sup>7</sup>

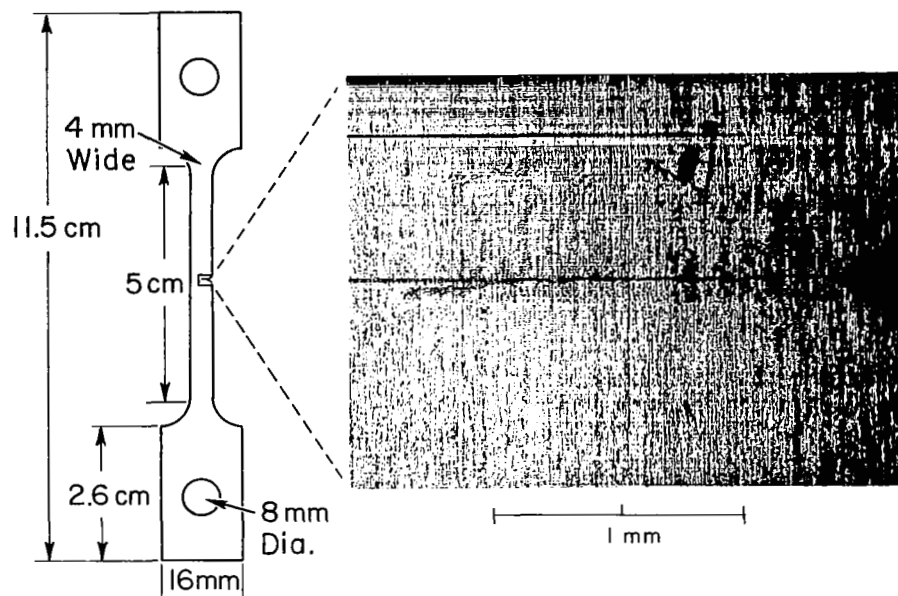
FIG. 4 TYPICAL PRECRACKED TENSILE SPECIMENS

The effect of hydrogen on crack propagation in Ti-8Al-1Mo-1V and Ti-5Al-2.5Sn was determined by testing notched specimens containing fatigue starter cracks (Figure 4) in  $\text{H}_2$  and He at both atmospheric pressure and  $10^4$  psi. The strain rate in the high pressure tensile tester was  $0.001 \text{ min}^{-1}$ . Cellulose acetate-carbon replicas were made of fracture surfaces.

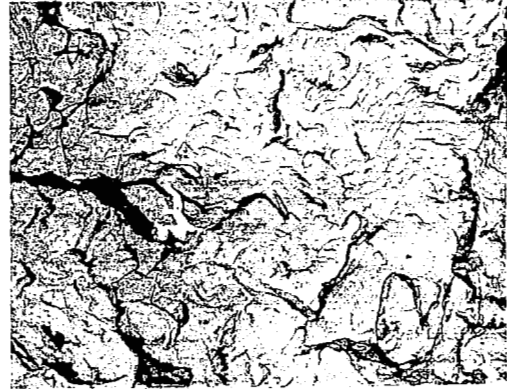
FIG. 5 CRACK SURFACES OF Ti-8Al-1Mo-1V PRODUCED  
IN  $10^4$  psi  $\text{H}_2$  AND He

The crack surfaces produced at  $10^4$  psi  $H_2$  were less ductile than those produced in other atmospheres. The surfaces were characterized by regions of faceted fracture topography typical of low ductility rupture (Figure 5a). This is contrasted with the dimpled structure seen in specimens tested at  $10^4$  psi He (Figure 5b). The failures were not brittle if specimens were not precracked.

The change in fracture mode in specimens tested in  $H_2$  at high pressure compared to atmospheric pressure suggests that higher pressure was required either to produce a higher surface concentration or to penetrate a surface barrier before the hydrogen could influence crack propagation. Fatigue cracks produced in air would have oxide films at the crack tip when the test was initiated. Oxygen and water vapor, present in tank hydrogen, could have reacted with the titanium preferentially to reform the oxide film when it was ruptured during the test.

The results show that hydrogen at the tip of a propagating crack can change the mode of rupture from ductile to brittle, and are consistent with the hydrogen embrittlement mechanism for the hot-salt cracking of titanium alloys.

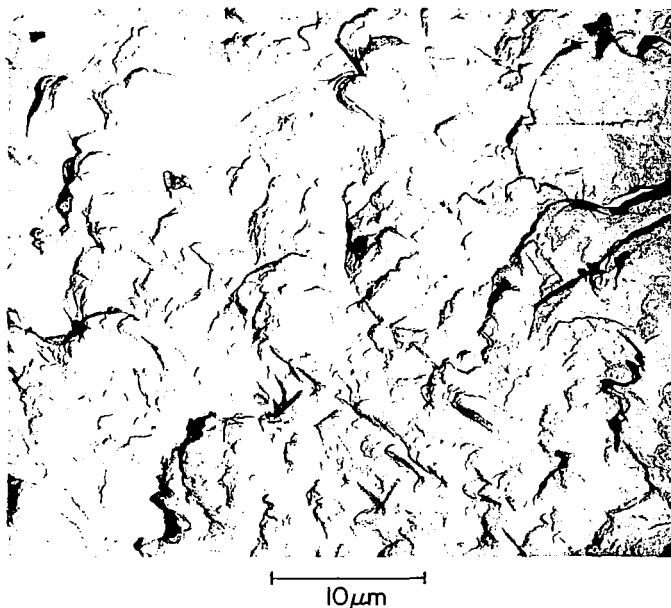
FIG. 6 CRACK SURFACES OF Ti-8Al-1Mo-1V PRODUCED  
IN H<sub>2</sub> OR He AT ATMOSPHERIC PRESSURE

The crack surfaces produced in both He and  $H_2$  at atmospheric pressure were similar and were characterized by dimples typical of ductile rupture (Figure 6). Thus, low pressure  $H_2$  in these tests had no effect on the fracture mode.

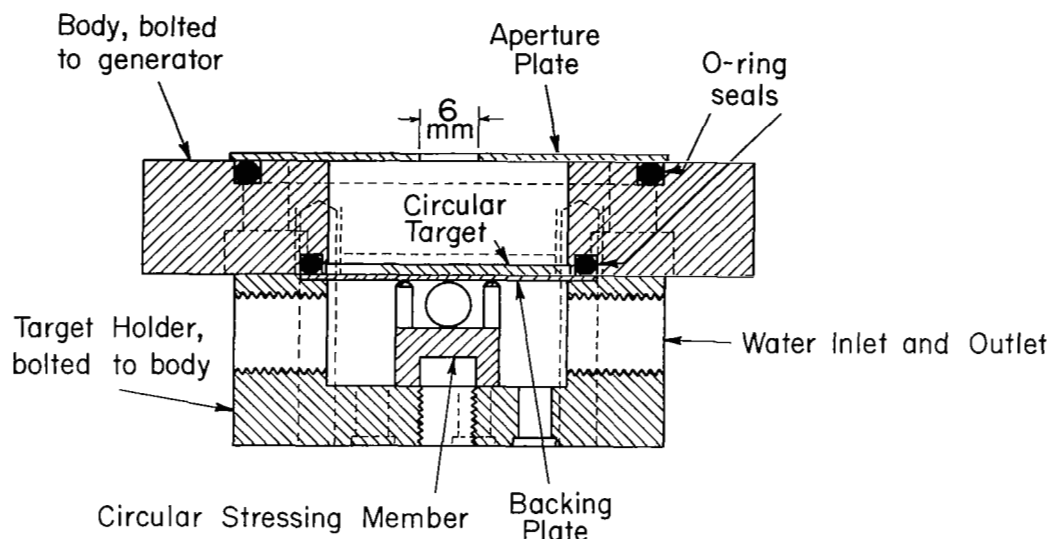
FIG. 7 TARGET AND ASSEMBLY FOR  $H^+$  BOMBARDMENT

A Texas Nuclear Model 6400 Neutron Generator was converted to a proton accelerator. The neutron generator is designed to ionize deuterium gas and accelerate it at a tritiated target to produce 14.8-Mev neutrons. When the generator is used as a proton accelerator, hydrogen instead of deuterium is introduced into the generator, and the ionizing coils are adjusted for maximum proton production. The protons, partially focused in the stripping tube, are accelerated in a potential field and, after further focusing, drift toward the stressed nontritiated titanium alloy in a specially designed water-cooled holder (Figure 7). The system is normally at a pressure of  $\sim 10^{-7}$  torr, but because of the introduction of hydrogen the effective pressure is only  $\sim 10^{-5}$  torr.

Because the beam diameter can be measured by its trace on the target (a result of the degradation of organic materials in the vacuum system), and the proton flux can be established from the beam current, the number of ions impinging per unit area can be calculated. Strain gages were used to measure the stress on the alloy surface exposed to protons.

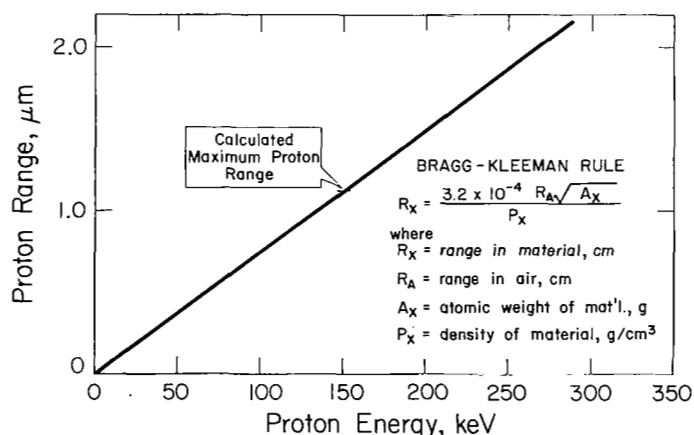
FIG. 8 EFFECT OF ENERGY OF PROTONS ON MAXIMUM RANGE IN TITANIUM

The range of protons in titanium or its alloys has not been measured, but penetration of at least a few hundred angstroms was desired so that the  $H^+$  would be injected well into the metal. The range of protons in titanium was calculated from their range in air by the Bragg-Kleeman rule.<sup>8</sup> Data for titanium are shown in Figure 8. The accelerating potential of 150 kev was selected from these data. Protons at 150 kev were calculated to have lost all their energy on traveling through 1.1  $\mu m$  of titanium.

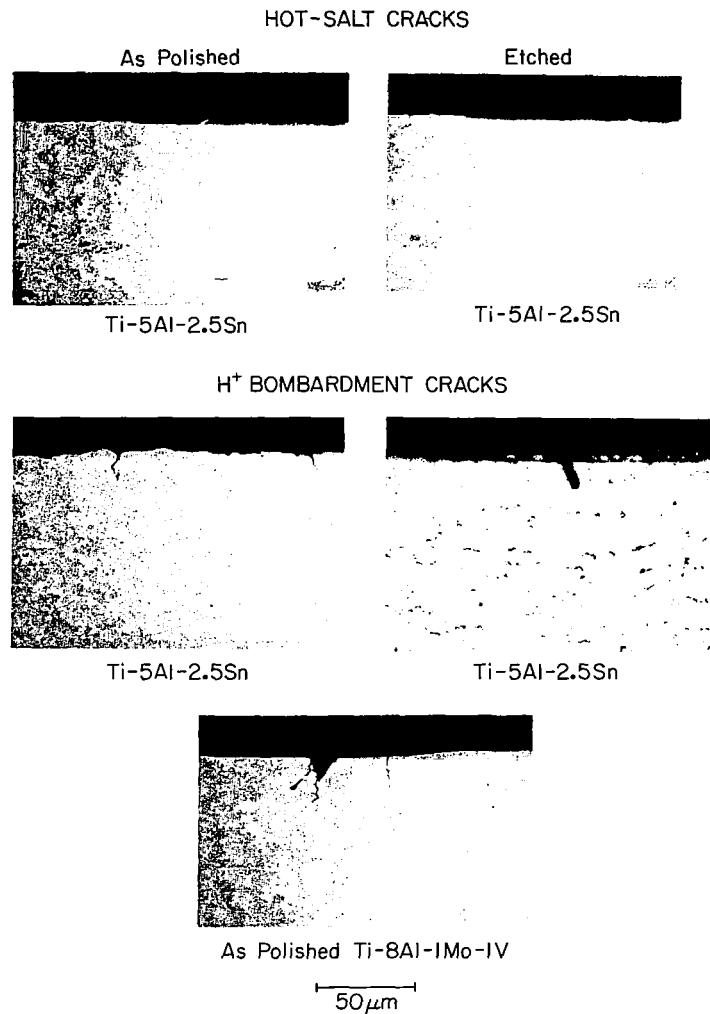
FIG. 9 CRACKS PRODUCED IN Ti-Al ALLOYS BY HOT SALT AND H<sup>+</sup> BOMBARDMENT

Hot-salt and  $\text{H}^+$ -bombarded cracked specimens are compared in Figure 9. In the as-polished condition, cracks deeper than one crystal are typically jagged because they are intercrystalline. In the etched condition, hot-salt cracks are typically blunt-ended as are cracks produced by  $\text{H}^+$  bombardment. Hydride structures were not visible in either alloy at 500X. Occasionally, the grain structure of the surface of a specimen was very clearly defined in a portion of the stressed areas as though it had been cathodically etched or as though hydrides were just forming at the grain boundaries. The hot-salt cracks in Figure 9 were produced by 30 hours exposure to NaCl at 350°C.

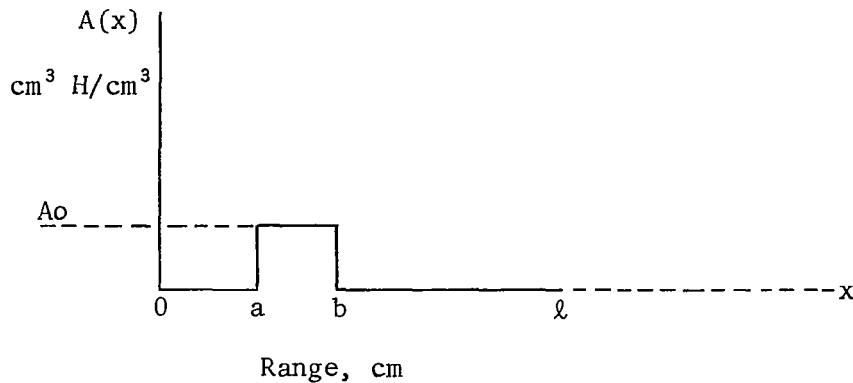
The proton injection was treated as a step function source of gas in the metal; to approximate a Gaussian distribution, a square wave centered about the average range was used.

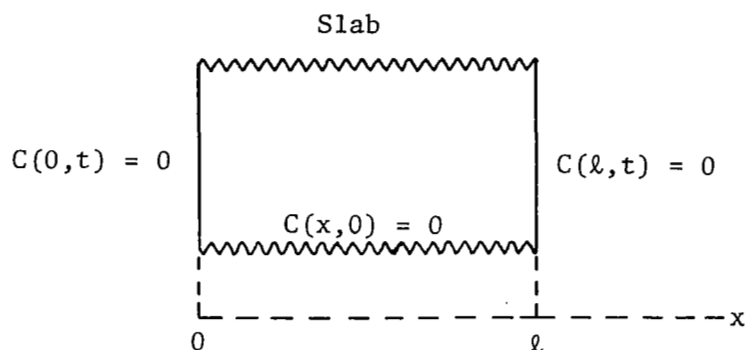
The boundary and initial conditions for the slab (specimen) were taken as

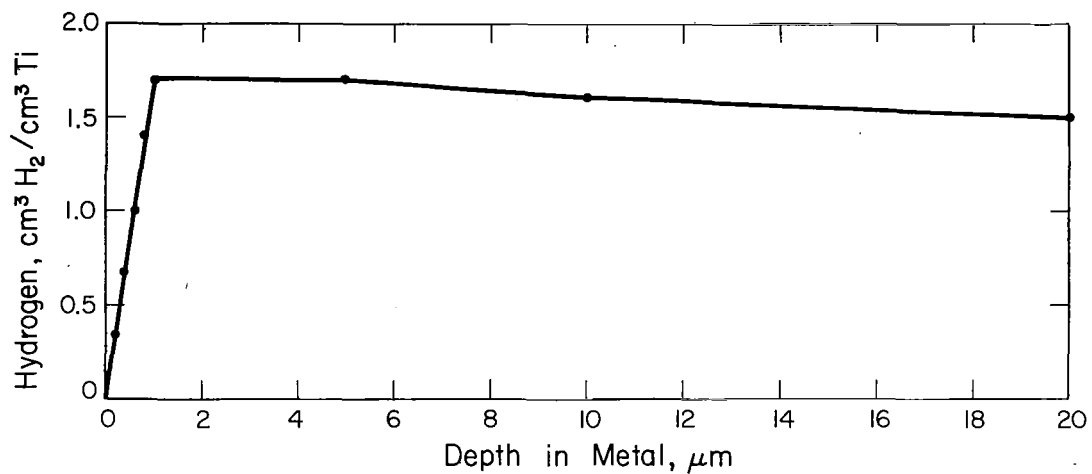
A typical profile is shown for a  $0.2 \mu\text{m}$  square wave source.

In the region of interest (1 and 10  $\mu\text{m}$  for Ti-5Al-2.5Sn and 1 and 30  $\mu\text{m}$  for Ti-8Al-1Mo-1V), concentration approached steady-state values within 15% or less. Concentrations were relatively insensitive to the width of the square wave (0.2 to 1.0  $\mu\text{m}$ ). The major uncertainty is probably the use of a value for  $D$  evaluated for the temperature measured at the midplane, although much of the diffusion occurred at the specimen surface. Published values for  $D_0$  and  $E_d$  were used<sup>12</sup> to evaluate the equation  $D = D_0 \exp(-E_d/RT)$ .
